Appendix T
27th Street Sewers Inspection Summary
26th Street Catch Basin Inspection Summary

**Subject: 27th Street Sewers Inspection Summary – November 19, 2020
26th Street Catch Basin Inspection Summary – November 24 and
December 8 and 11, 2020
Former Carnotite Reduction Company Site
434 East 26th Street
Chicago, Illinois**

Appendix U
Site Inspection Summary - October 2020
Temporary Power Supply Infrastructure

**Subject: Site Inspection Summary – October 2020
Temporary Power Supply Infrastructure
Former Carnotite Reduction Company Site
434 East 26th Street
Chicago, Illinois**

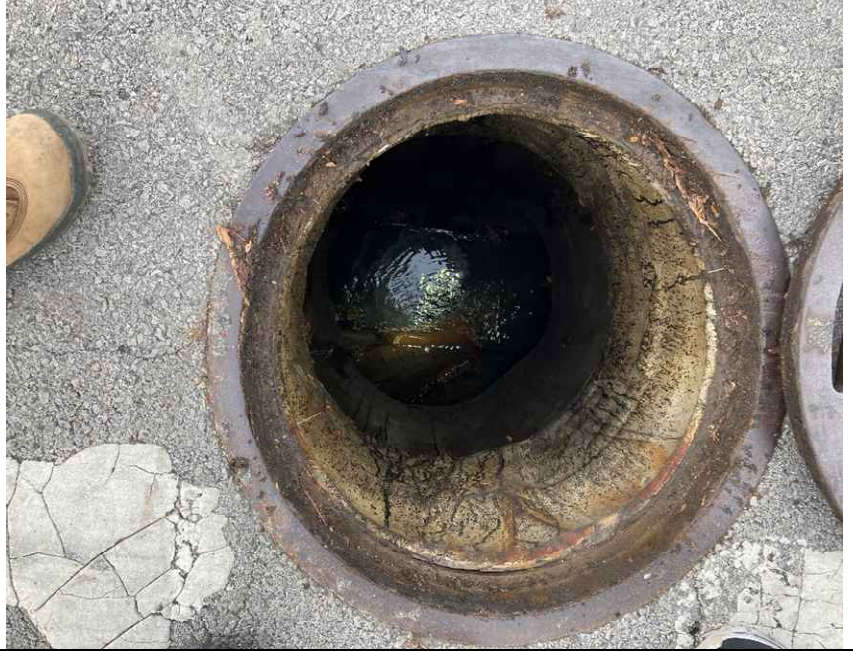
Photo: 1

Description: Photo of sewer manhole on Dr. Martin Luther King (King) Drive at the 27th Street ROW. Water was observed flowing from east facing influent pipe, although the influent pipe was not visible. 30-inch King Drive sewer pipe was visible. No significant debris was observed.

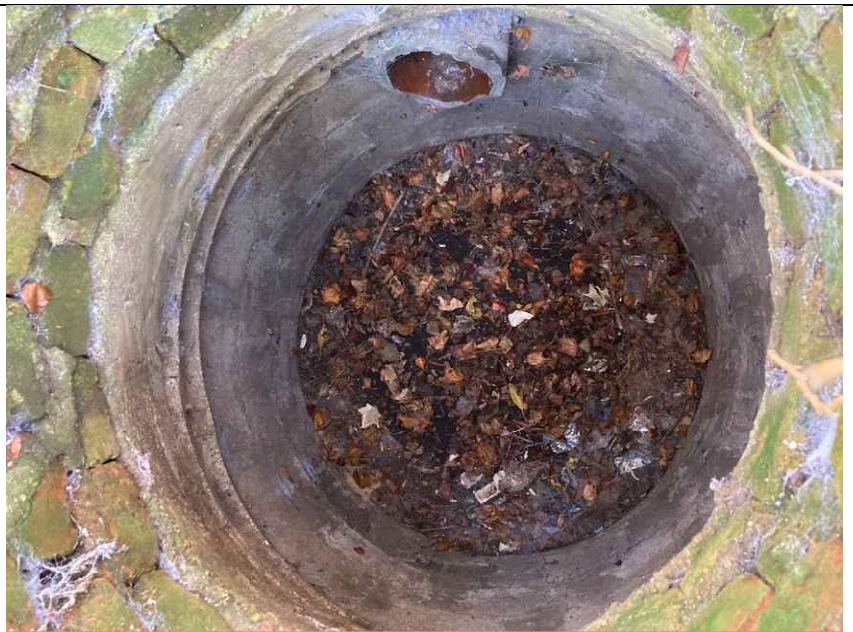
Photo: 2

Description: Photo of sewer Manhole H east of Prairie Shores parking lot adjacent to the wooded area south of tennis court. Sewer observed to contain significant amount of leaves and debris. Primary east/west inlet and outlet pipes not visible. Inlet near top of manhole appears to be coming from Manhole G.

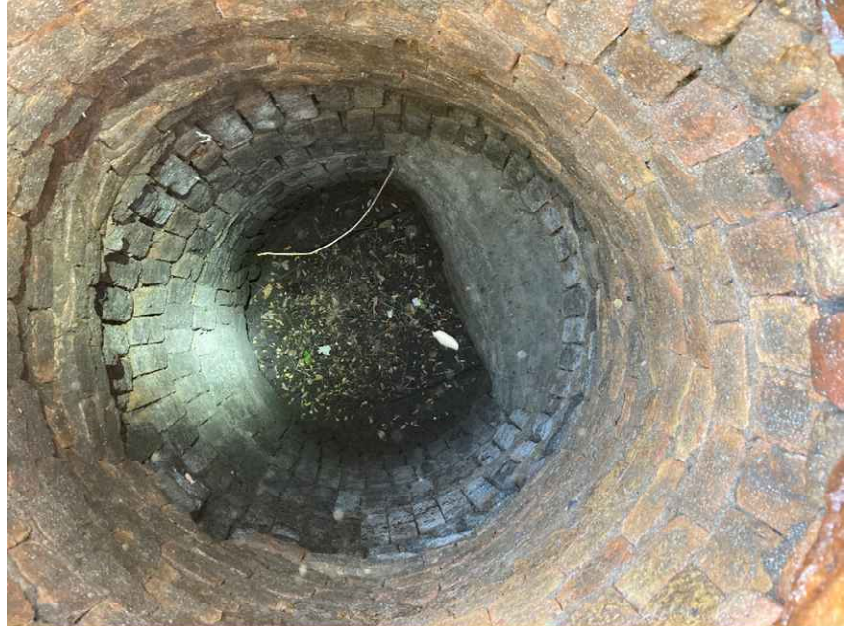
Photo: 3

Description: Photo of the sewer Manhole I about 80 feet east of Manhole H in grass area along the 27th Street ROW. East/west in and outflows pipes are visible at bottom of sewer. However, leaves and debris are also present.

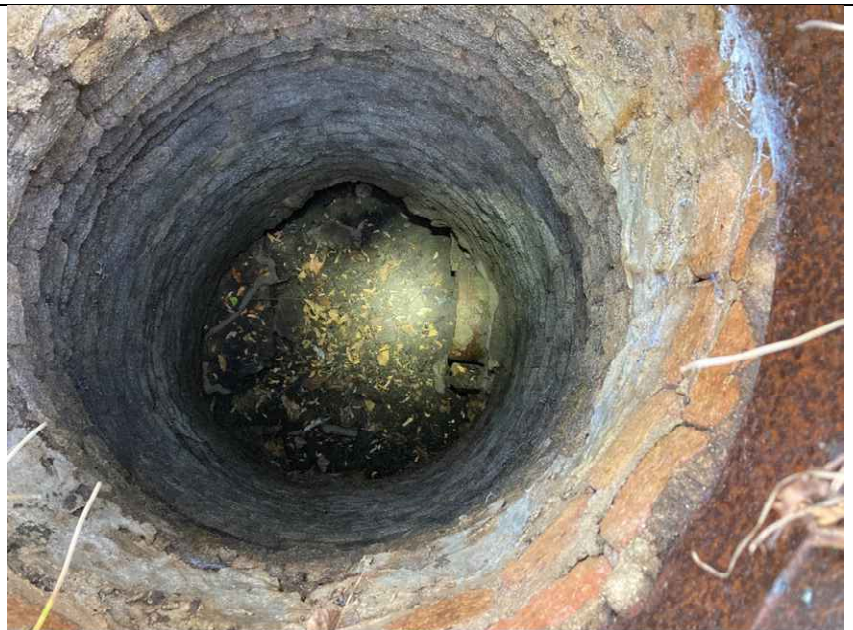
Photo: 4

Description: Photo of the sewer Manhole J about 50 feet east of Manhole I along the 27th Street ROW in grass area inside site fence adjacent to Ellis Avenue. East/west in and outflows pipes are visible at bottom of sewer. However, leaves and debris are also present.

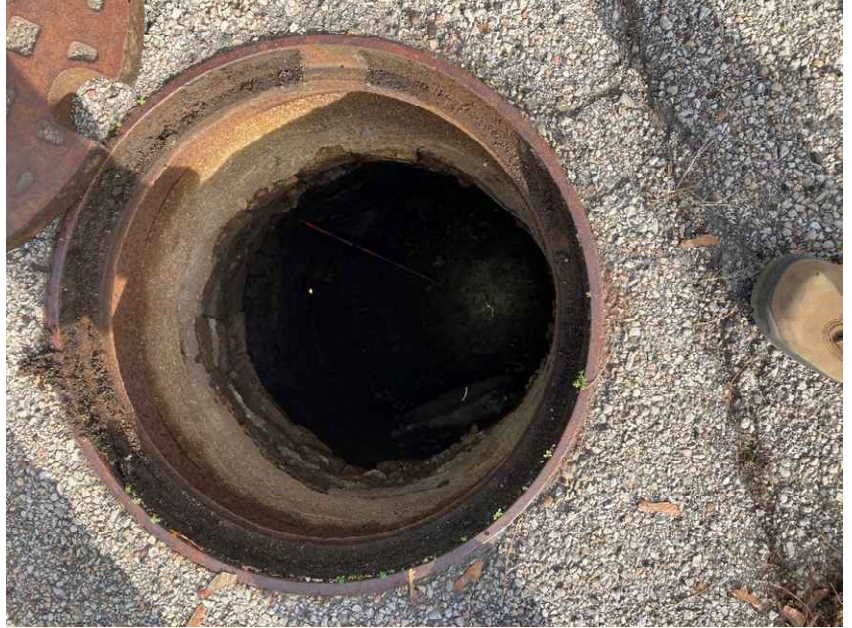
Photo: 5

Description: Photo of sewer Manhole K located in intersection of Ellis Avenue and 27th Street, about 35 feet east of Manhole J. East inflow pipe visible, west outflow pipe not visible. Debris including bricks is present.

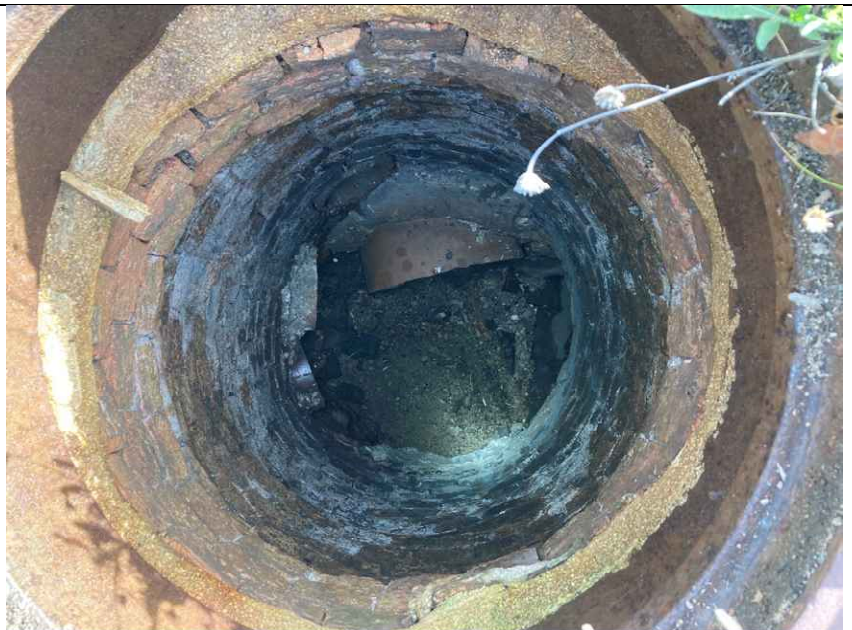
Photo: 6

Description: Photo of sewer Manhole L located in 27th Street about 80 feet east of Manhole K. Large ~30-inch pipeline on east wall of manhole, pipes leading north, south, and east are also visible. Some debris in bottom of manhole.

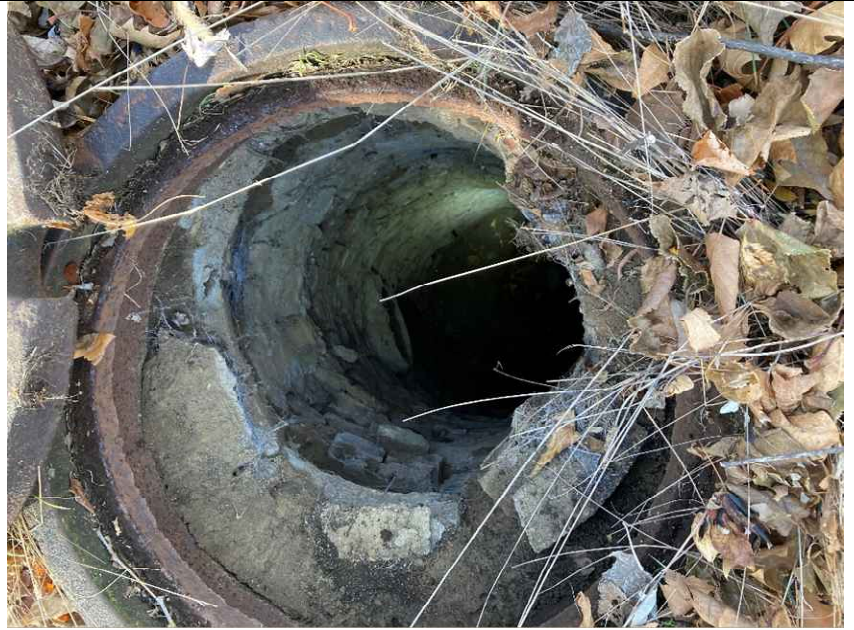
Photo: 7

Description: Photo of sewer Manhole G, located east of tennis courts. Pipes visible leading southwest toward Prairie Shores parking lot and south/southeast.

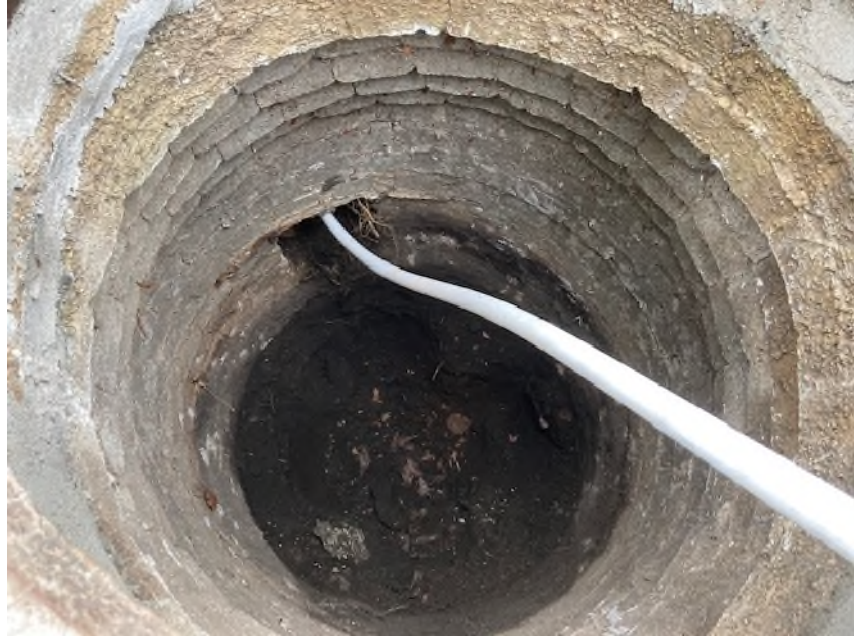
Photo: 1

- The south catch basin manhole was recently reconstructed and both the catch basin and outflow pipe were cleaned by DWM.
- The diameter of the south catch basin outflow pipe is documented as 10 inches in City of Chicago sewer drawings.

- No obstructions were noted in the south catch basin lateral.
- In the north catch basin, some build up of soil/sludge was noted in the lateral 6 to 12 inches from the manhole.

Description: Photo of reconstructed catch basin on south side of East 26th Street east about 13 feet east of Dr. Martin Luther King (King) Drive. Note outflow pipe on northwest wall of manhole heading toward King Drive and tubing containing endoscope entering the pipe.

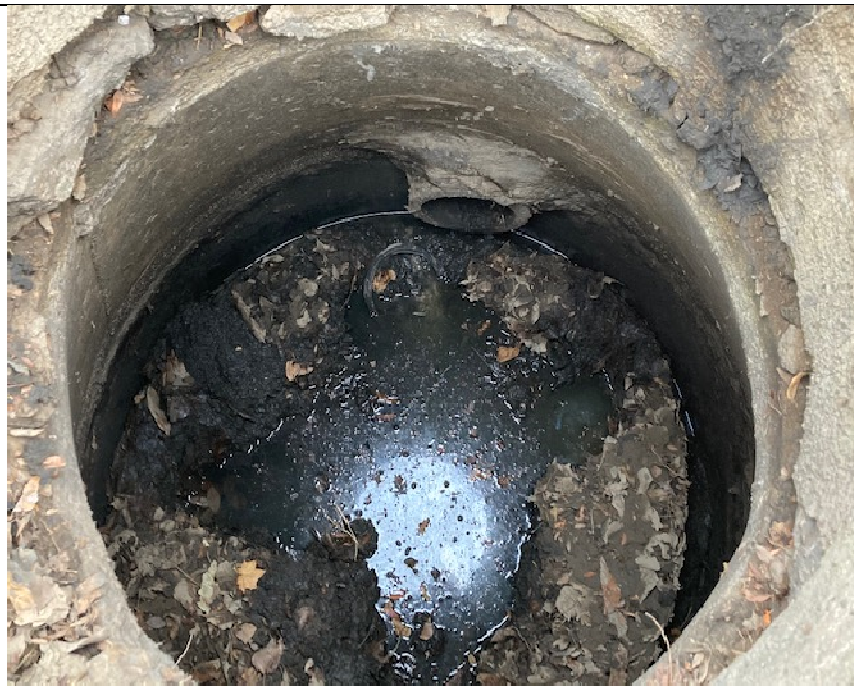
Photo: 2

- In the north catch basin, an outflow pipe, estimated as 10 inches in diameter, was observed on the south manhole wall approximately 5 to 6 feet below ground surface in the manhole.

Description: Photo of catch basin in the north curblane of East 26th Street, about 14 feet east of King Drive. An outflow pipe toward main sewer line in 26th Street center line was observed on the south manhole wall. Depth to outflow pipe estimated at 5 to 6 feet below ground surface.

- Between the December 8 and 11 site visits, the City of Chicago Department of Water Management (DWM) cleaned the north catch basin and removed a metal vortex restrictor covering the outflow pipe.

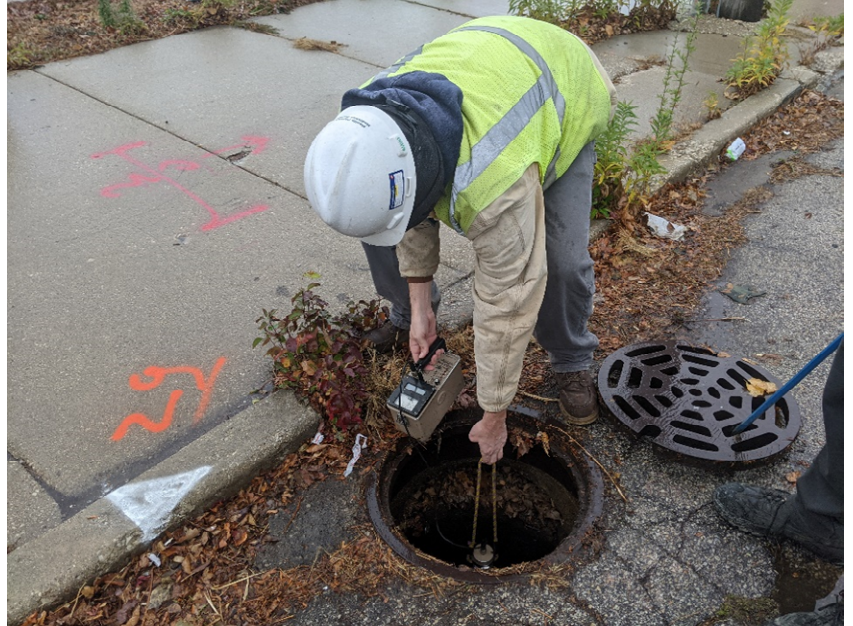
Photo: 3

- Stan A. Huber Consultants, Inc. lowered a Ludlum Model 2221 into the north catch basin to measure gamma activity in the catch basin. A reading of 1,800 counts per minute (CPM) was detected. The site-specific screening level indicating potential contamination is equivalent to twice background, which is 5,666 CPM for this instrument.

Description: Photo of SAHCI taking radiation readings with a Ludlum Model 2221 in the catch basin along the north curb of East 26th Street. A reading of 1,800 counts per minute (CPM) was detected approximately two feet below surface level. Site-specific screening level is 5,666 CPM (2x background).

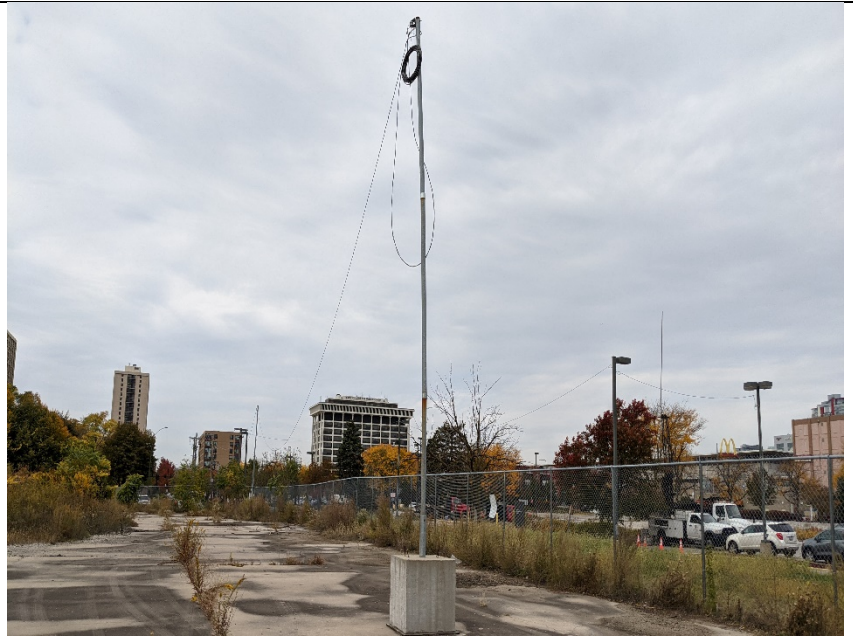
Photo: 4

- The power pole for air monitoring station (AM)-1 was upright and the power line was attached, and it extended to the next power pole to the east.
- The next power pole (between AM-1 and AM-2) was still upright with the power line wound up and attached to the top of the pole.

Description: Photo of the first utility pole after AM-1 looking back at AM-1. Note the wound-up power line.

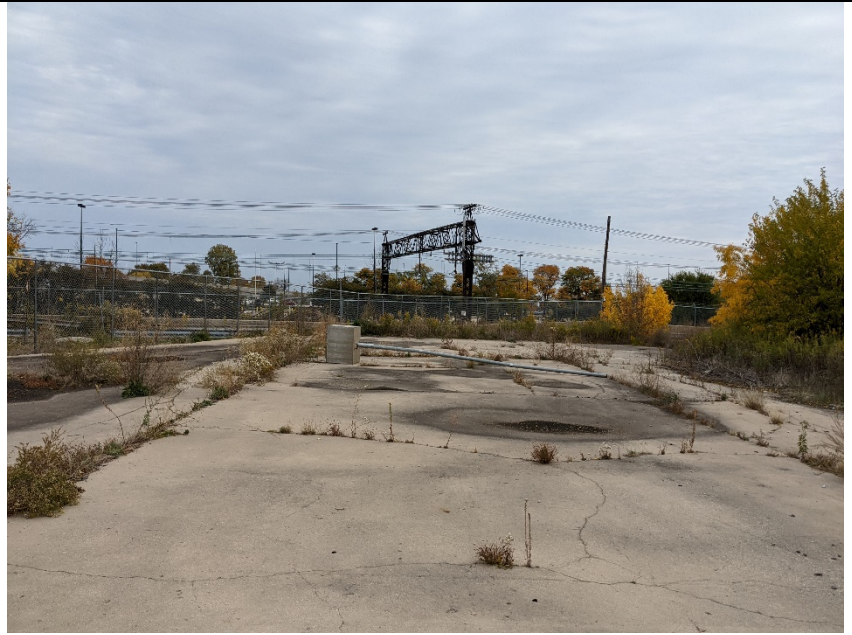
Photo: 5

- The remaining three (3) power poles (including AM-2) on the east side of the site were tipped over with no power lines present around or between them.

Description: Photo of utility pole that is tipped over between AM-1 and AM-2. Note that no power lines are present.

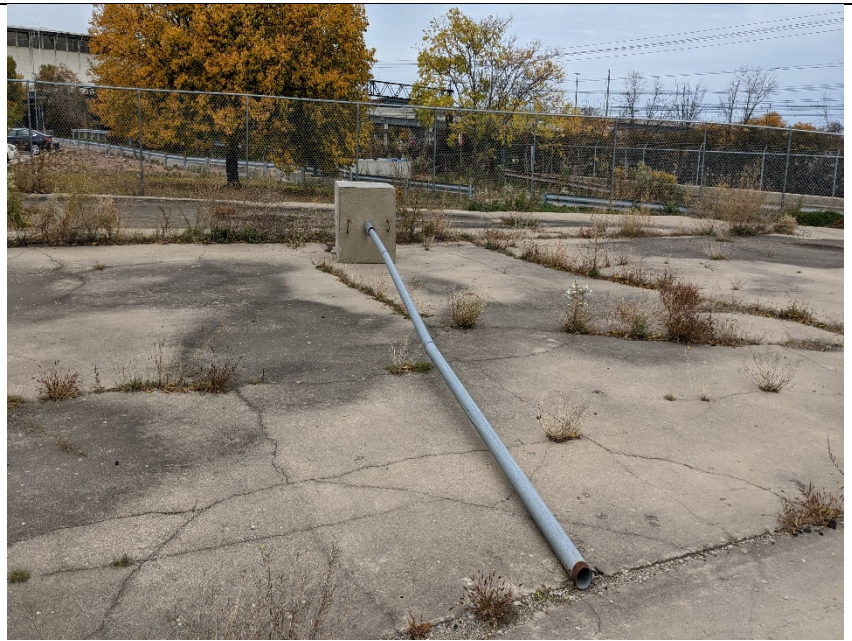
Photo: 6

Description: Photo of utility pole that is tipped over between AM-1 and AM-2. Note that no power lines are present.

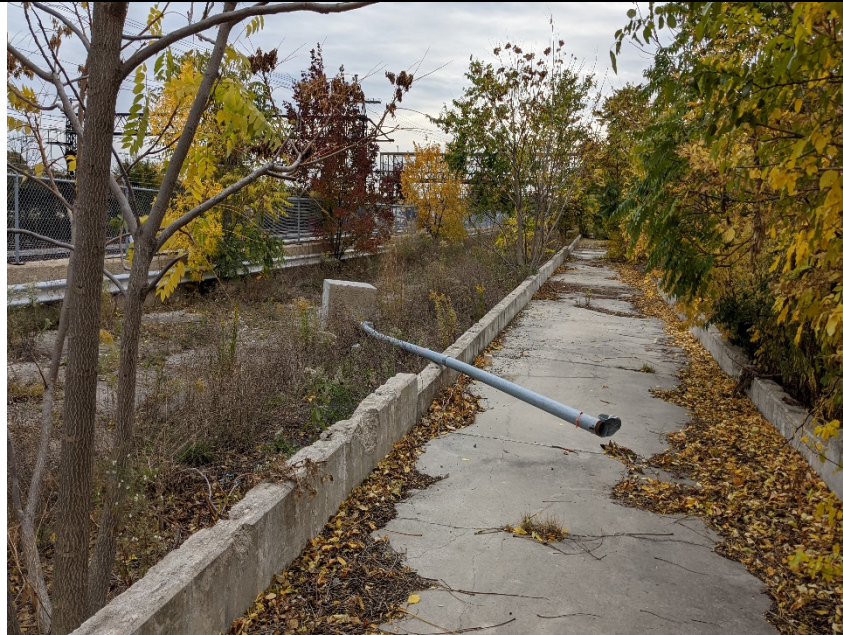
Photo: 7

Description: Photo of utility pole at AM-2. Note that no power lines are present.

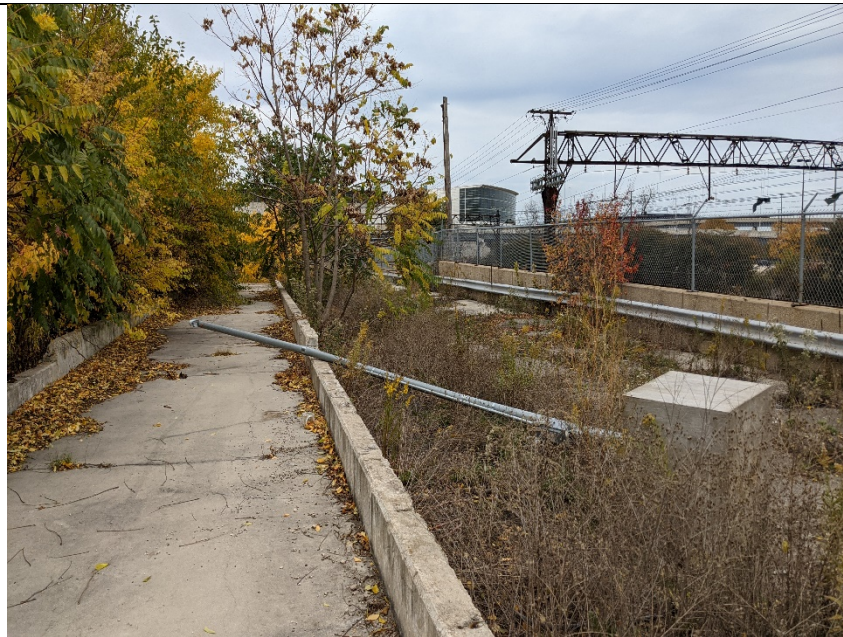
Photo: 8

Description: Photo of utility pole at AM-2. Note that no power lines are present.

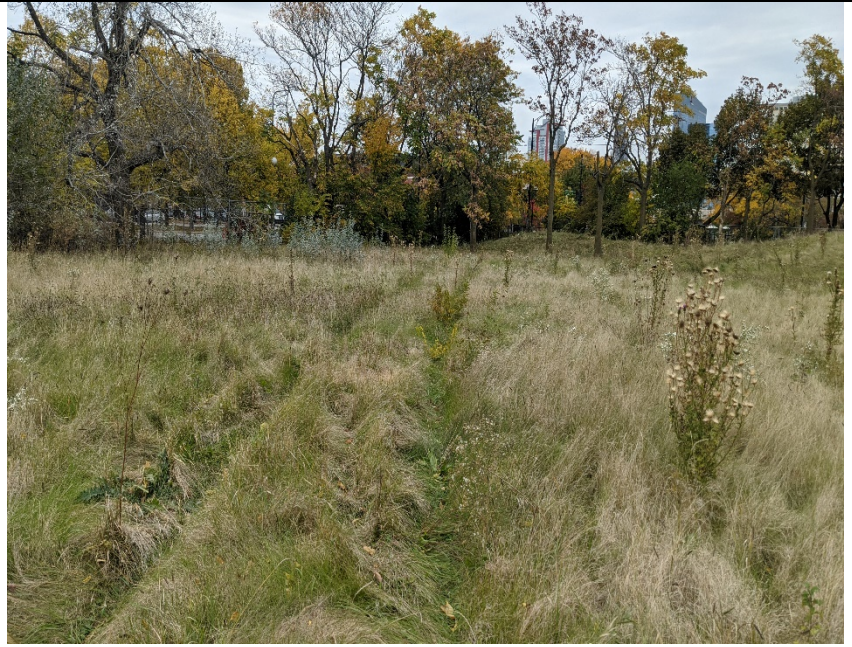
Photo: 11

- The site is overgrown with weeds, tall grasses, and trees throughout the site.
- All fencing appeared to be intact in the areas that were observable.
- There was one set of tire tracks present in the grass on the west side of the site.

Description: Photo of tracks through the site near AM-4.

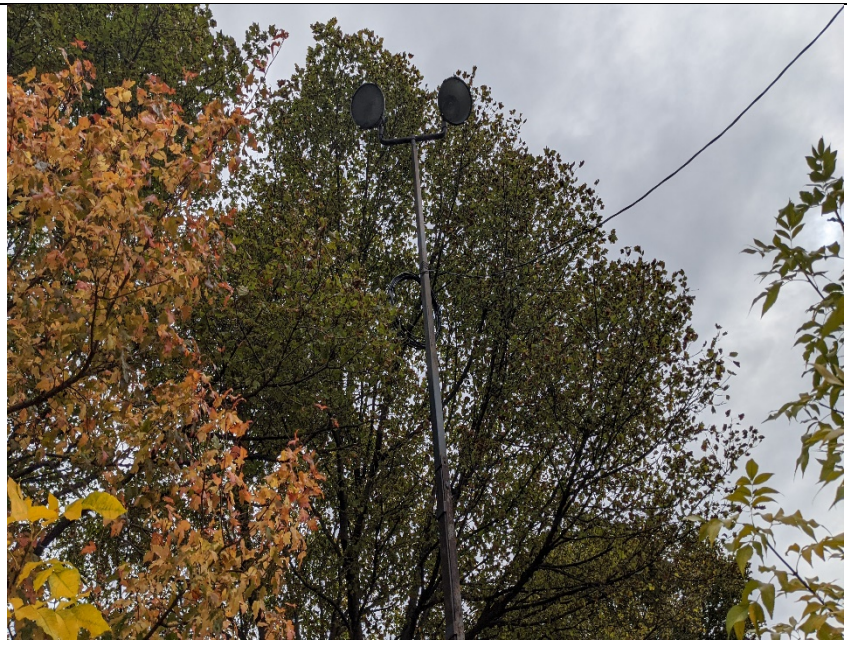
Photo: 18

- All the power poles on the west side of the site were still standing and had power lines connected between them. The power lines extended from the AM-4 toward AM-3 and further to the east until the last power pole adjacent to East 26th Street where the power line was wound up and attached to the top of the tennis court light pole.

Description: Photo of powerline attached to a tennis court light pole to the immediate west of E. 26th Street.

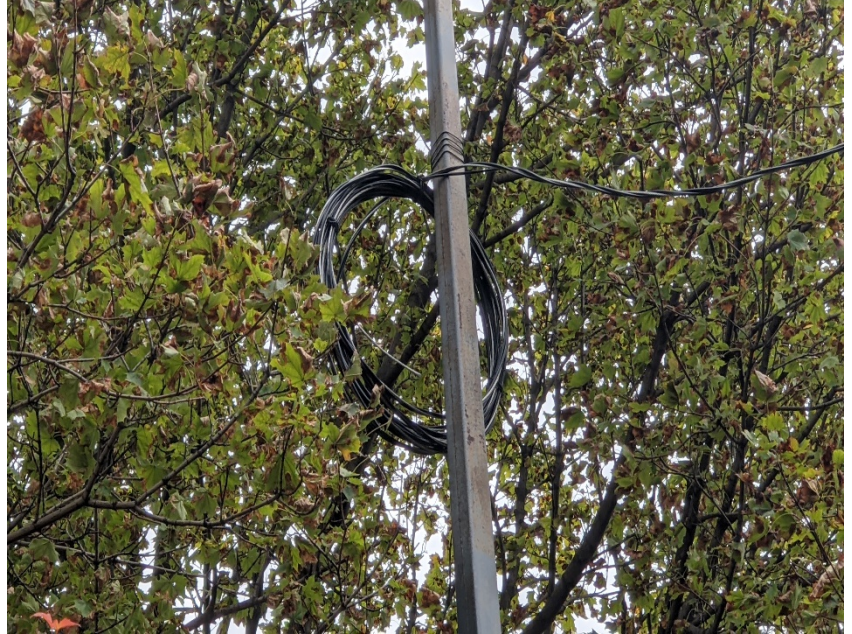
Photo: 19

Description: Close-up photo of wound-up powerline attached to the tennis court light pole to the immediate west of E. 26th Street.
